Rimkus Consulting Group, Inc.
Eight Greenway Plaza, Suite 500
Houston, TX 77046
(800) 580-3228 Telephone
(713) 623-4357 Facsimile

Re: RCG File No: 11009971
LLV Number: 0209452
VMF Location: 1530 Greensmark Drive in Houston, Texas
Subject: Final Report

Rimkus Consulting Group, Inc. was retained to examine LLV 0209452, VIN 1GBCS10E4M2908832. The fire occurred on June 13, 2016 at around 12:30 P.M. the operator of the vehicle at the time of the fire, was unavailable for interview but reportedly stated the vehicle's engine died while delivering mail on his route and backfired during subsequent attempts to restart it. Soon thereafter, smoke was observed from beneath the hood as well as flames.

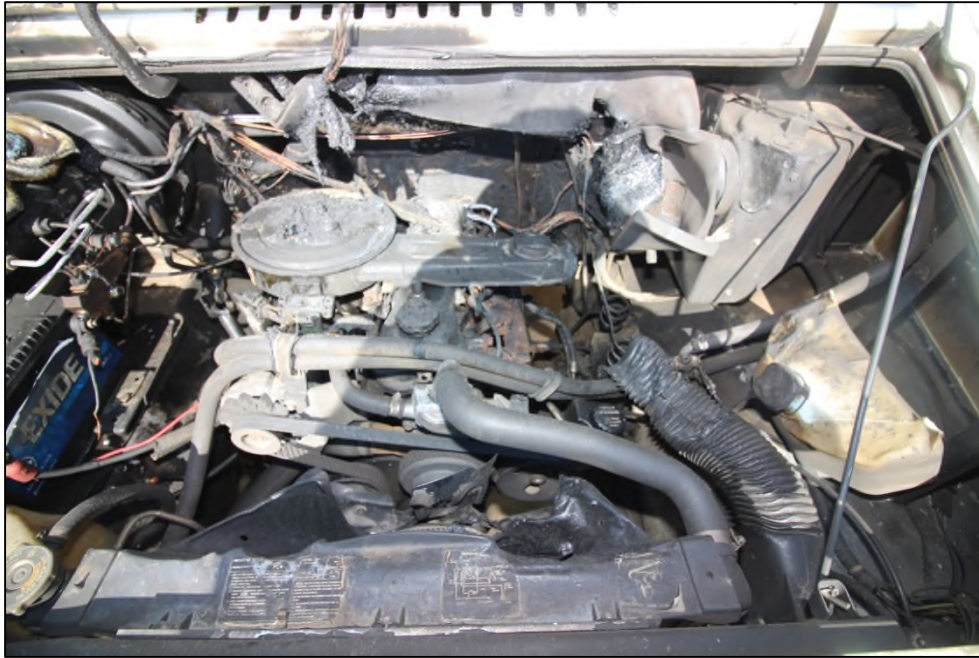
Photograph 7

The engine compartment.

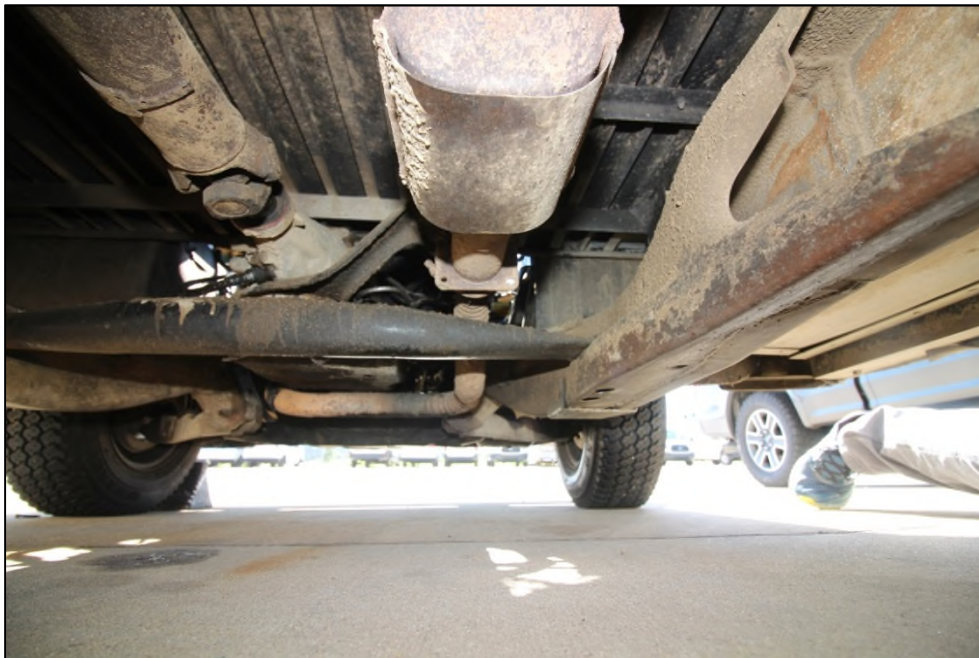
Photograph 8

The undercarriage, as seen while facing the front of the vehicle.

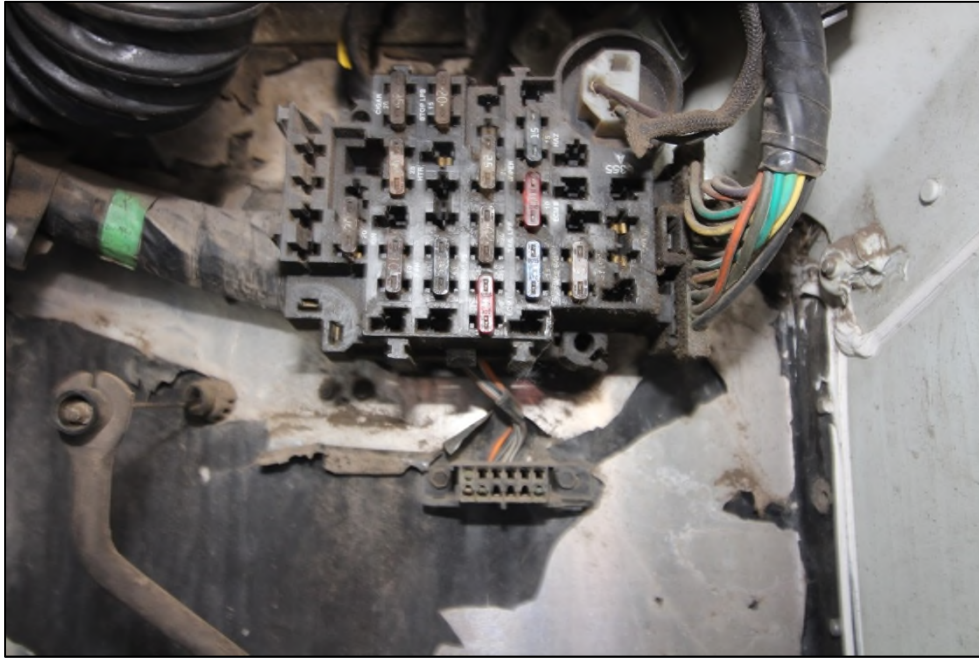
Photograph 9
The fuse panel.

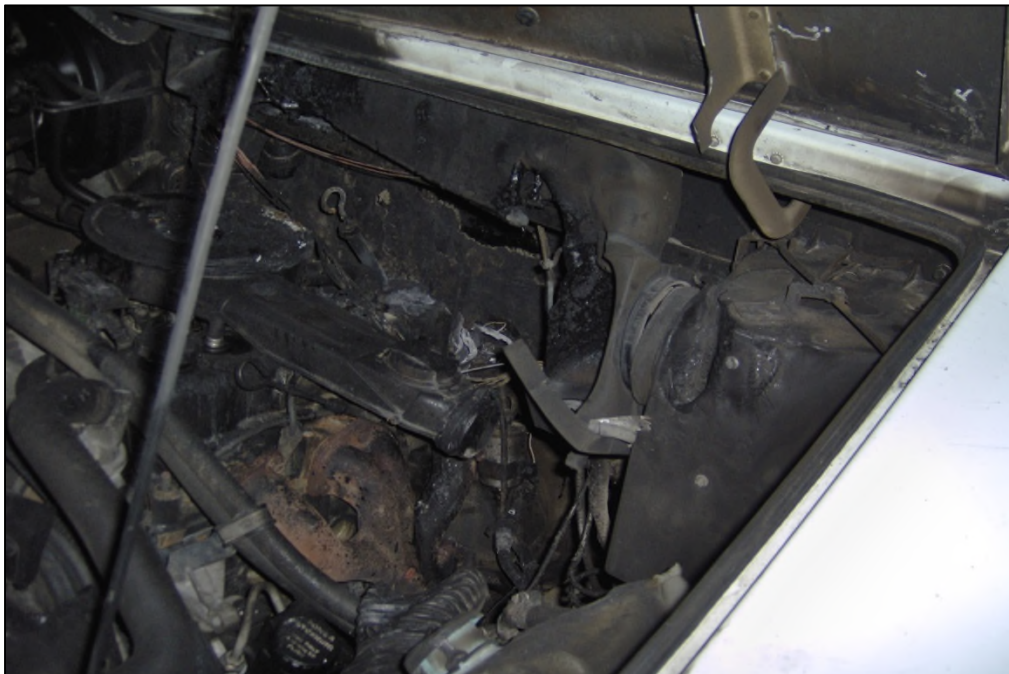
Photograph 10
The left rear side of the engine compartment; observe the fore damage progressing up from the lower portion of the engine.

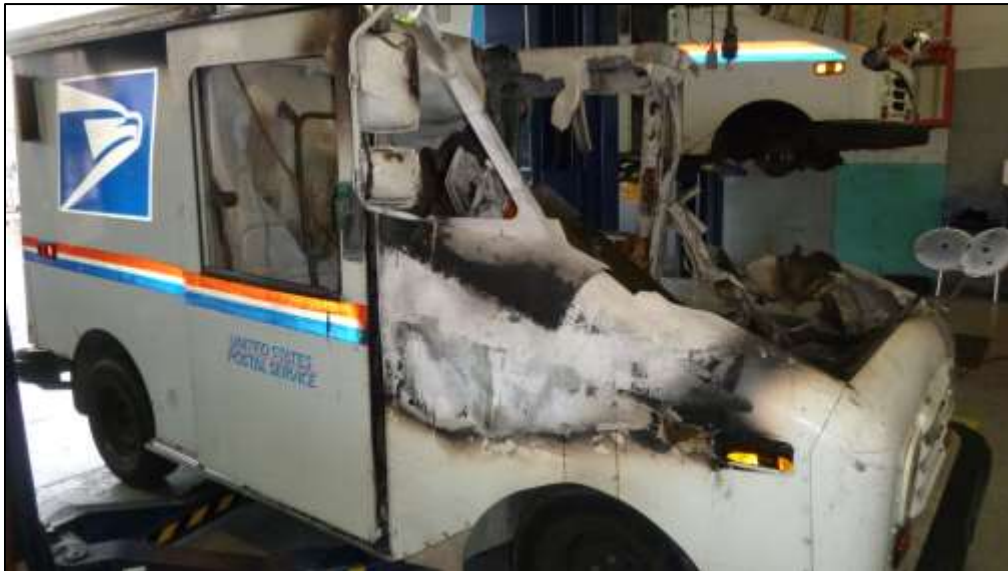
Photograph 1

Front view of the vehicle right side.

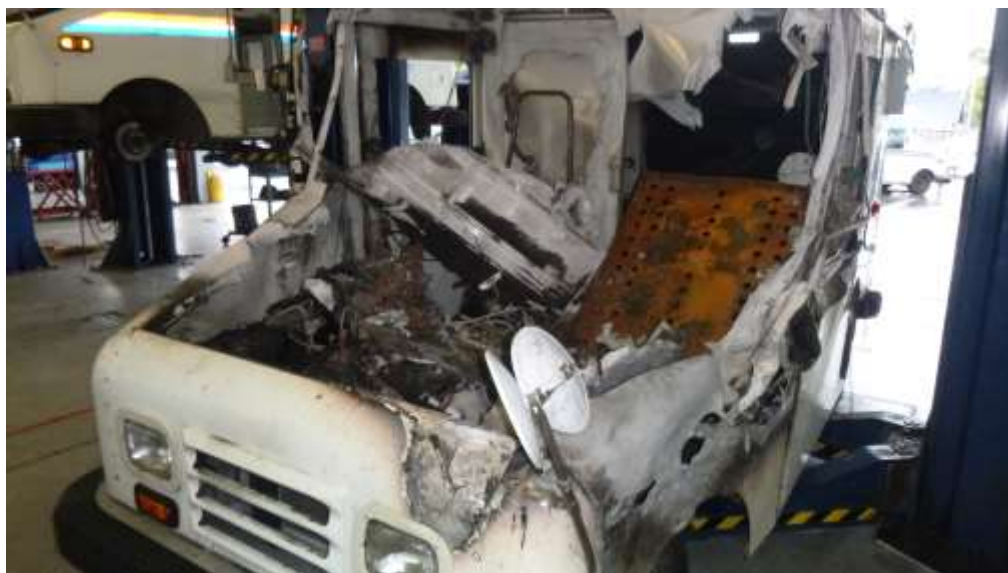
Photograph 2

Front view of vehicle mail side.

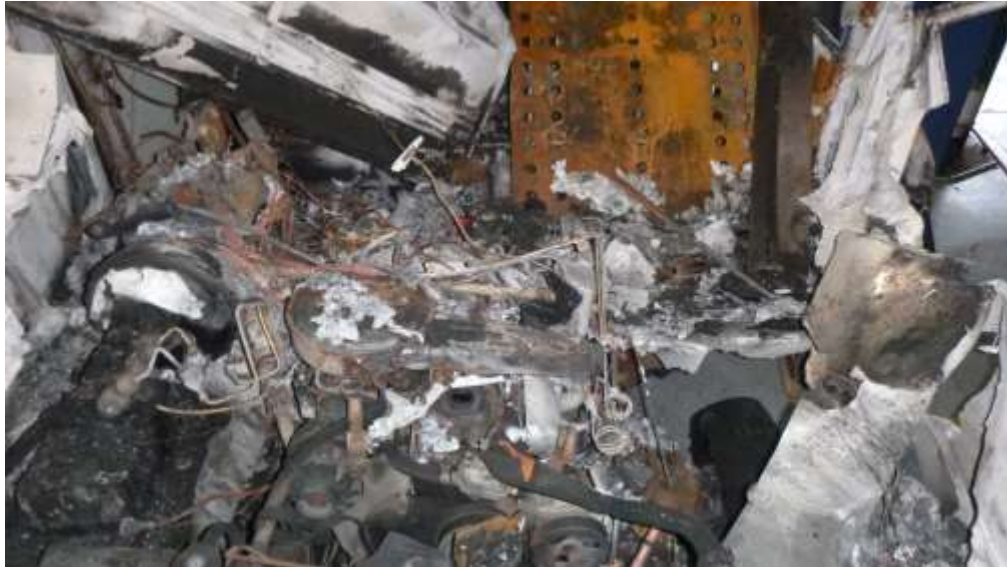
Photograph 3

The engine compartment was examined. The 2.2-litre engine was equipped with a standard ignition coil. Severe fire damage was observed along the bulkhead of the engine compartment including the right and mails side of the engine and related components. The most distinct area of fire damage was observed along the rear of the engine in proximity to the fuel line test port. Fire patterns communicated upward and outward. The damage included breaching the composite hood material at the approximate left mail side, center and rear portions.

Engine view of the fire damage.

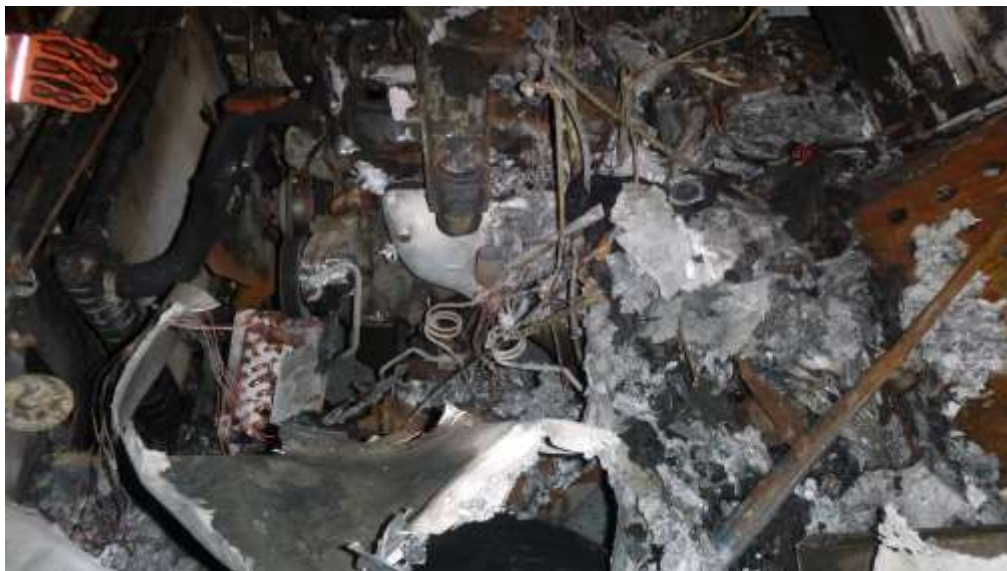
Photograph 4

Additional image of engine damage from mail side.

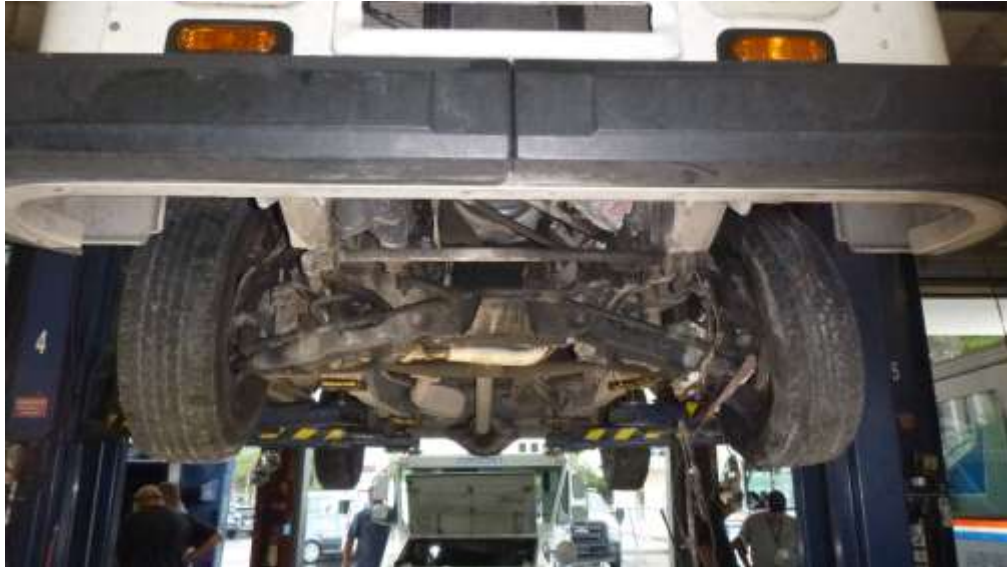
Photograph 5

Front view of vehicle undercarriage.

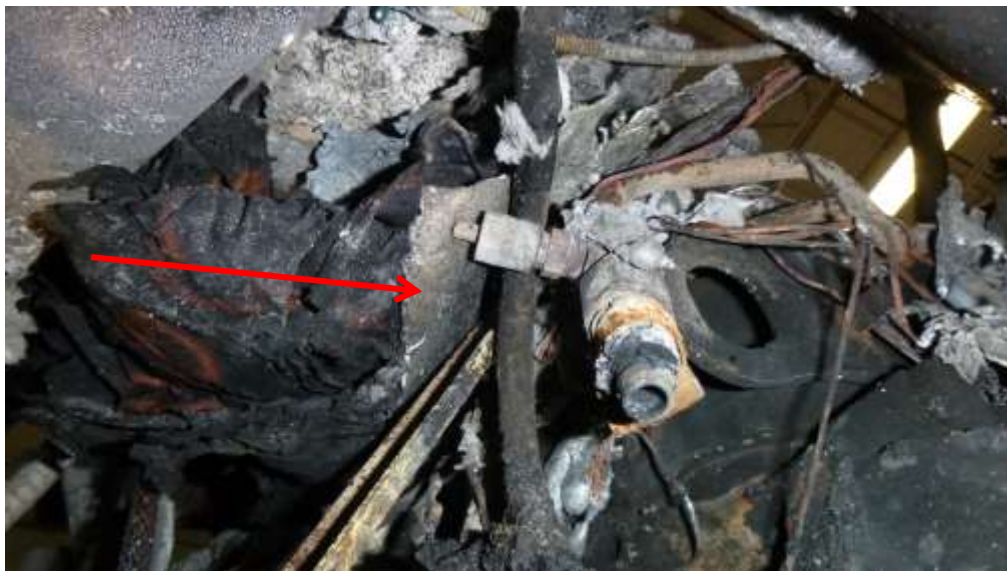
Photograph 6

2. The specific area of fire origin was determined to be on the rear of the engine.
3. The specific ignition sequence and cause of the fire was consistent with ignition of either leaking or atomized fuel encountering a hot surface area of components or other competent ignition source.

Fuel line test port rear of engine.

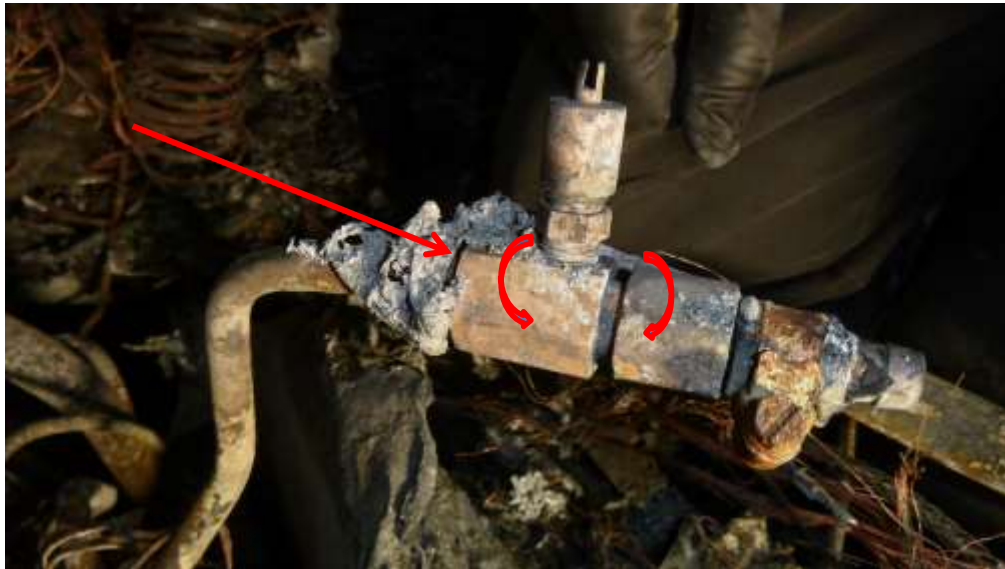
Photograph 7

Alternate view of the loose fitting fuel line test port.

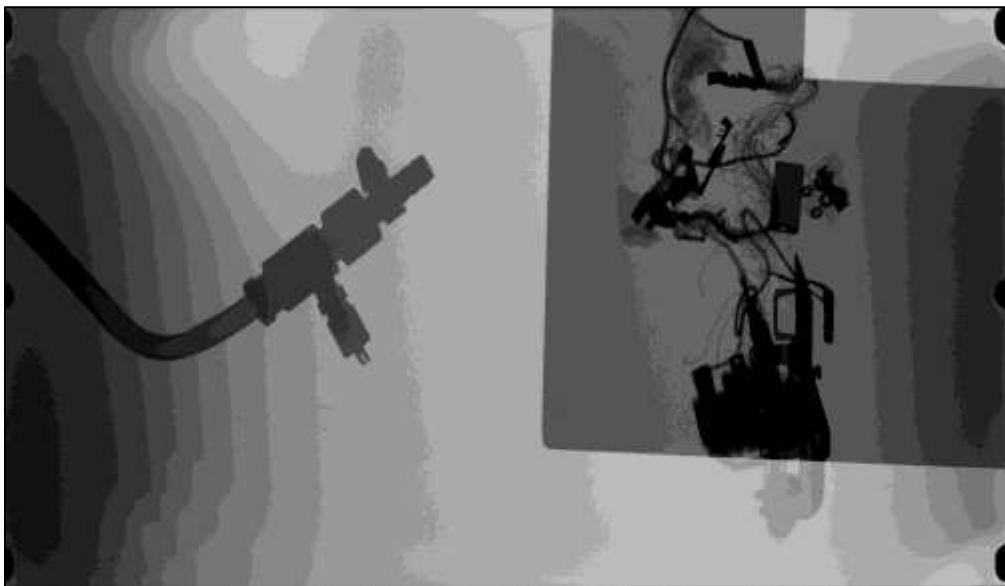
Photograph 8

X-ray of the of the loose fitting fuel line test port.

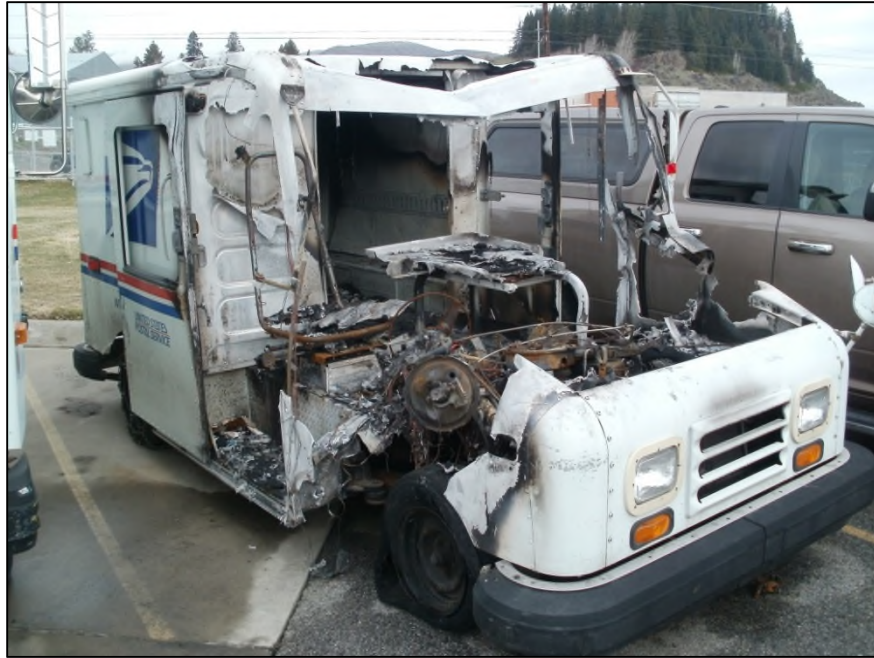
Photograph 1

Damage to the front and passenger compartment of the vehicle was extensive.

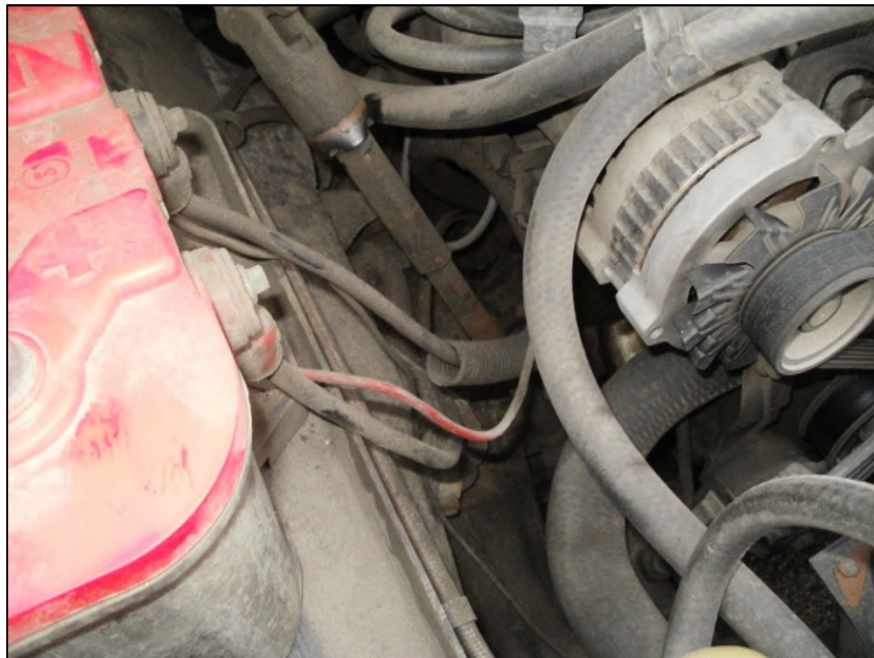
Photograph 2

Exemplar indicating proximity of the battery the alternator.

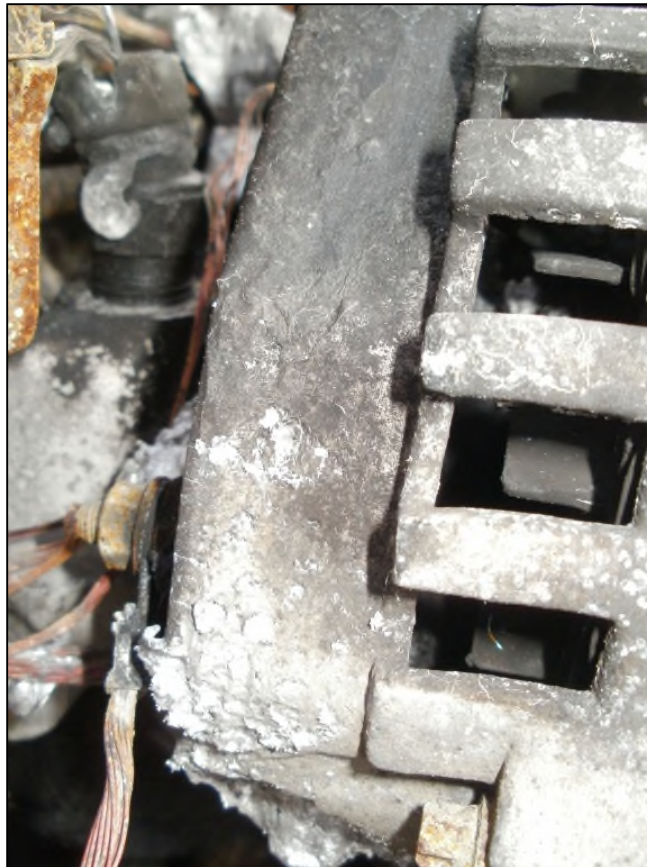
Photograph 3

Dent, arcing, and pitting on the alternator.

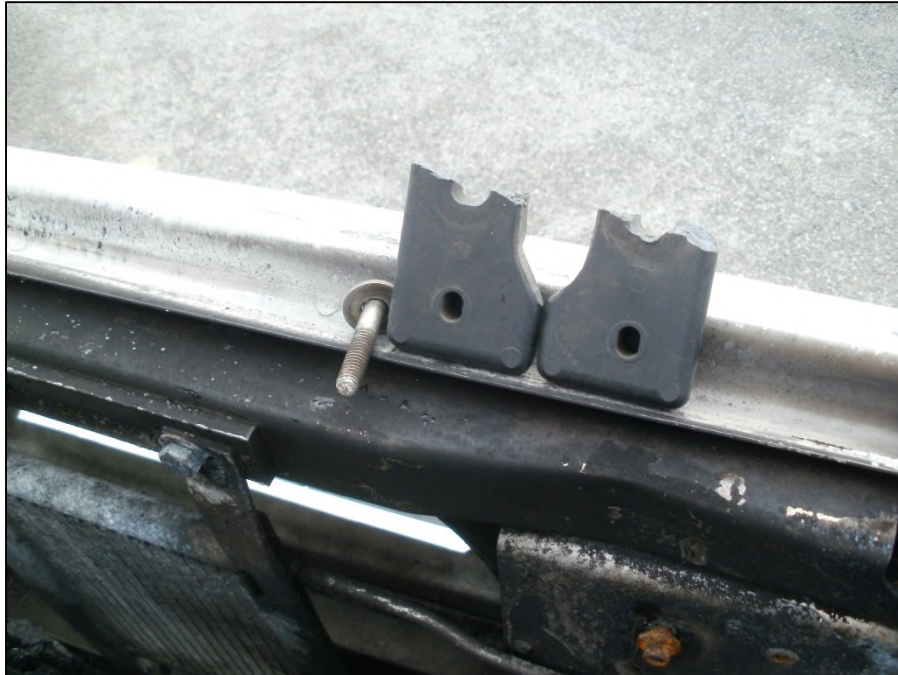
Photograph 4

Clamp discovered in parking space - this was the only vehicle for which one was not accounted.

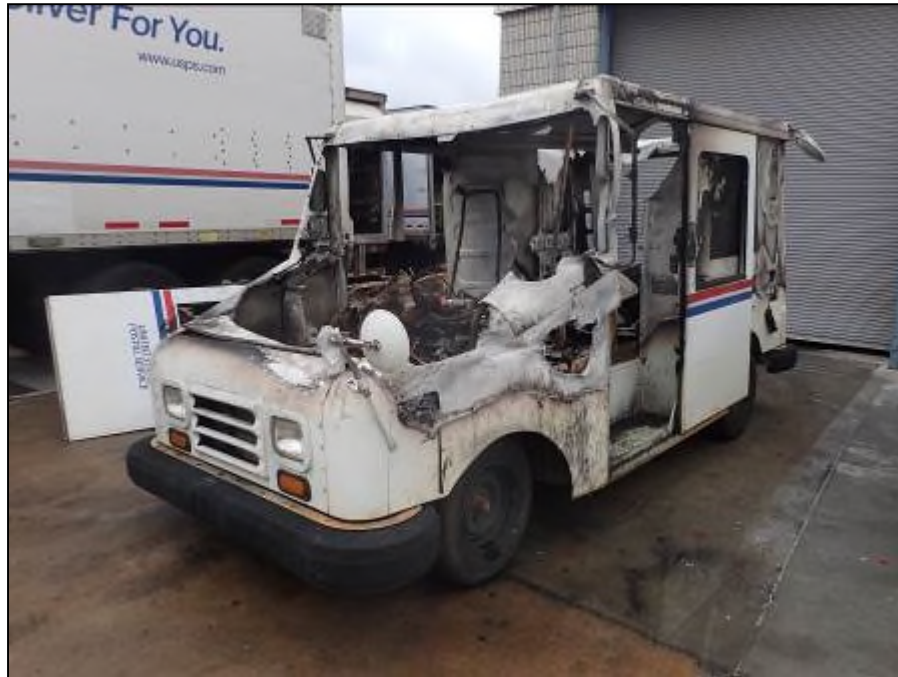
Photograph 1

View of the front and mail exterior.

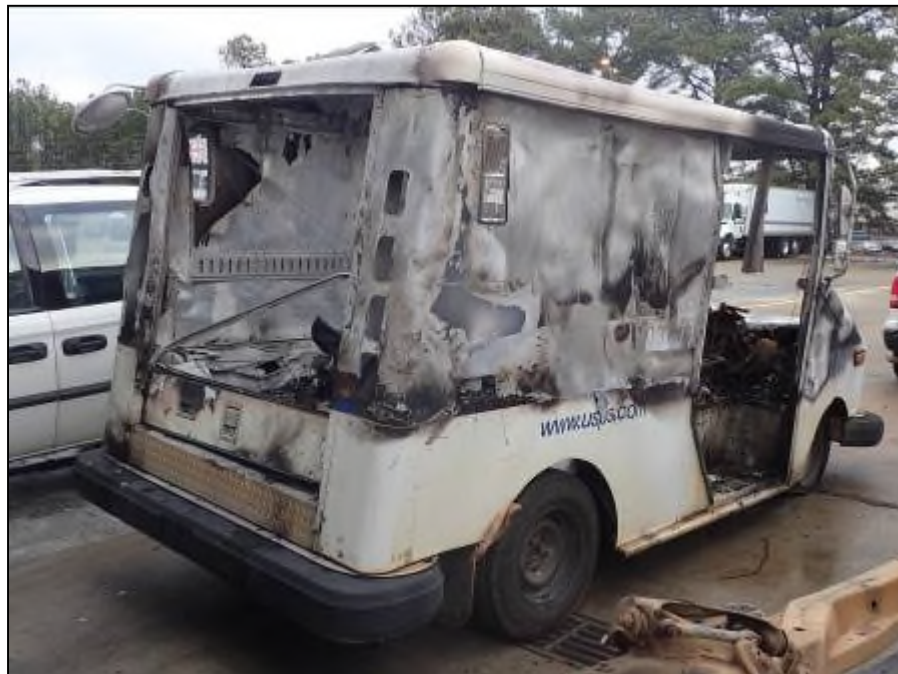
Photograph 2

View of the driver and rear exterior.

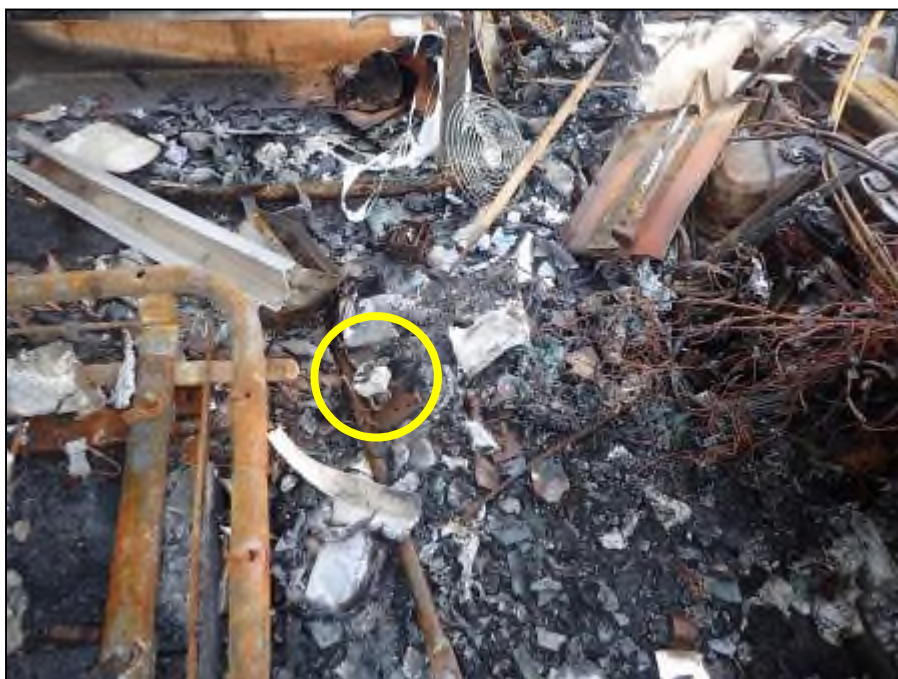
Photograph 4

View of the headlamp switch on the driver's side floor.

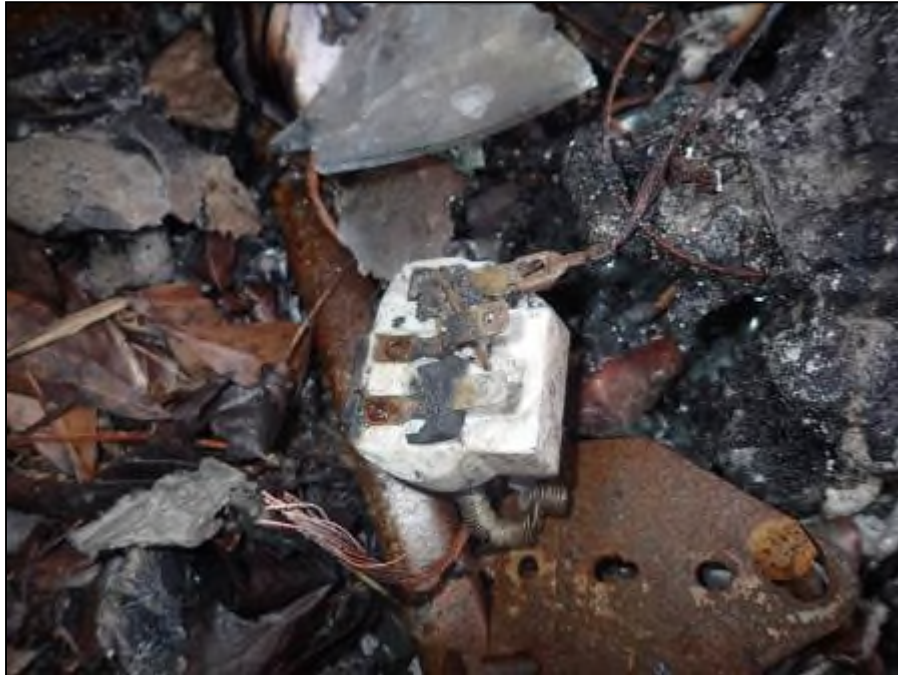
Photograph 5

View of the headlamp switch.

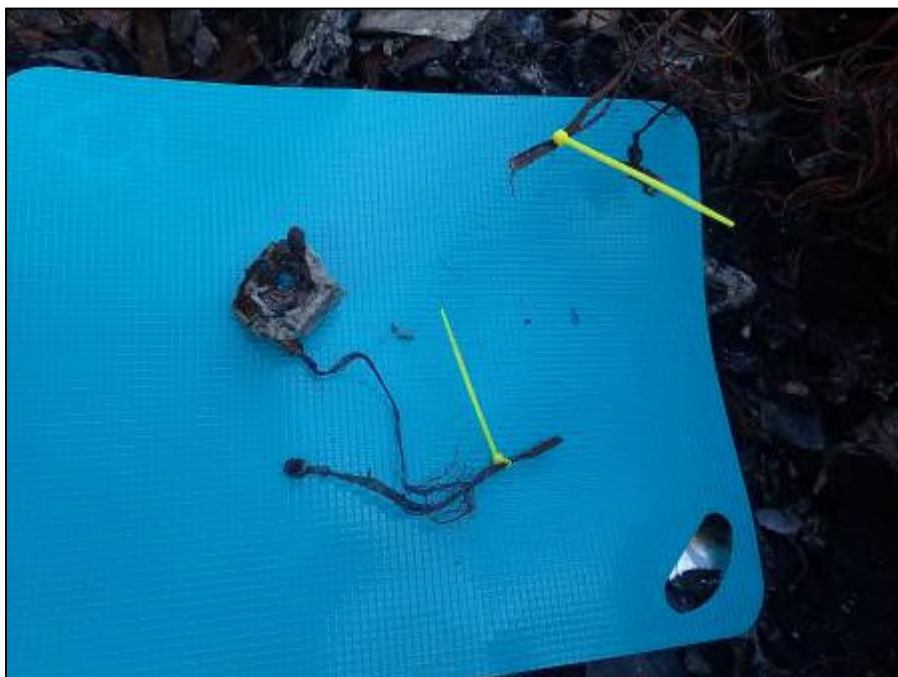
Photograph 6

View of the headlamp switch and electrical conductors.

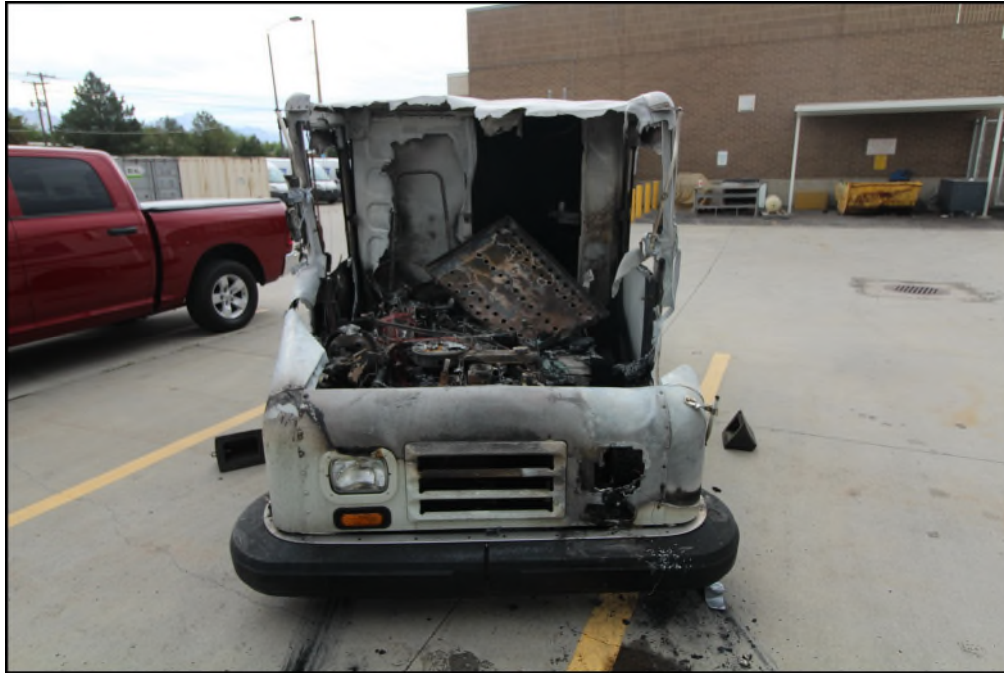
Photograph 1

Front view of the LLV.

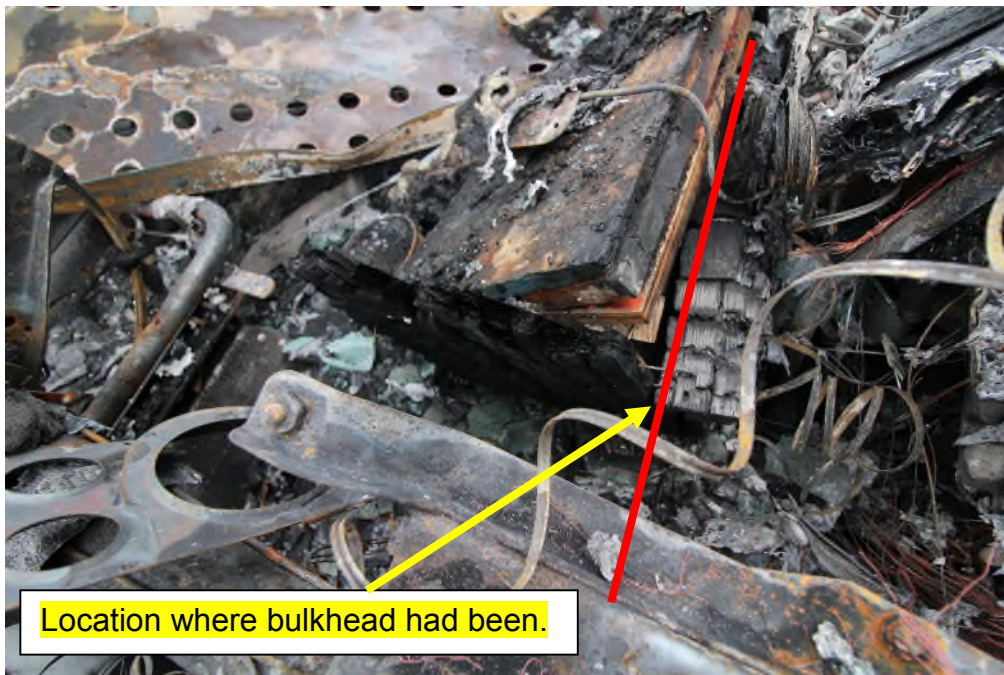
Photograph 2

Driver's side at area where bulkhead had been located.

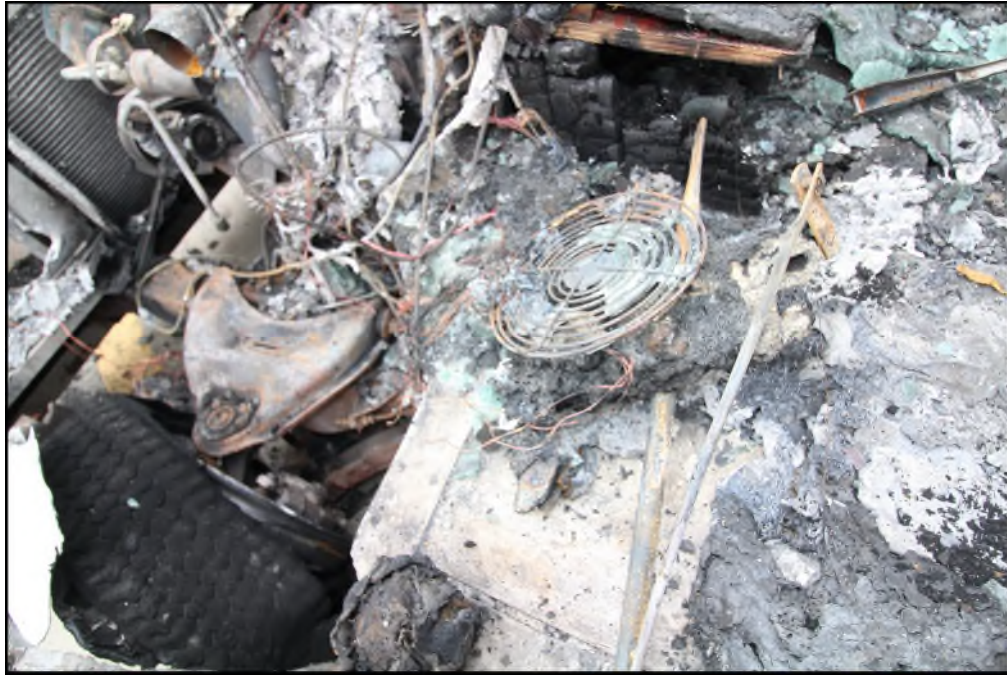
Photograph 3

Fan guard on mail side.

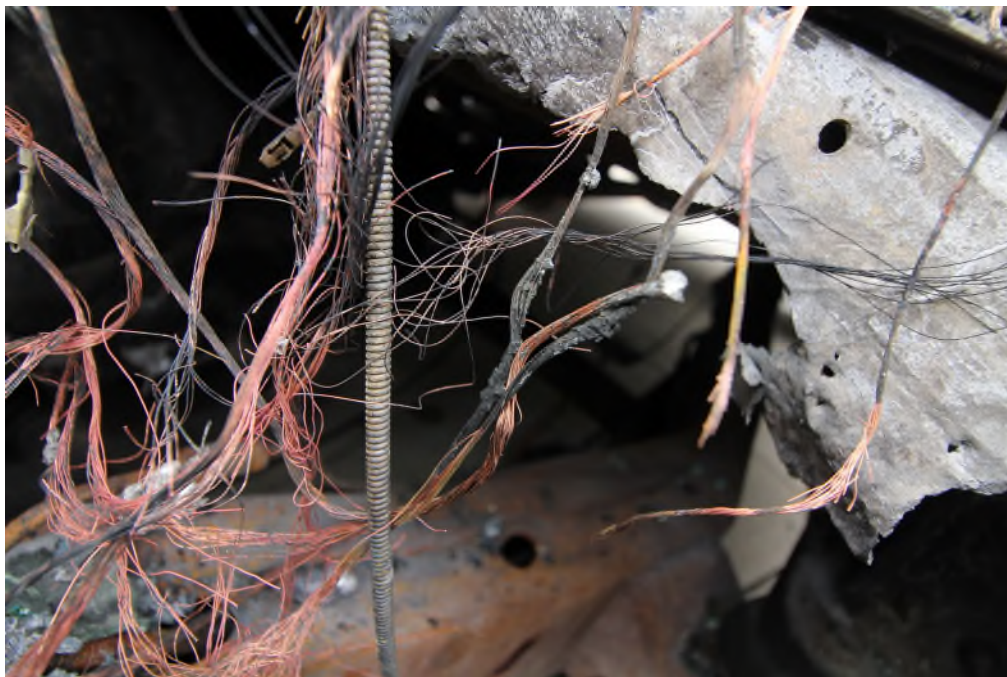
Photograph 4

Electrical conductors near where fan guard was discovered.

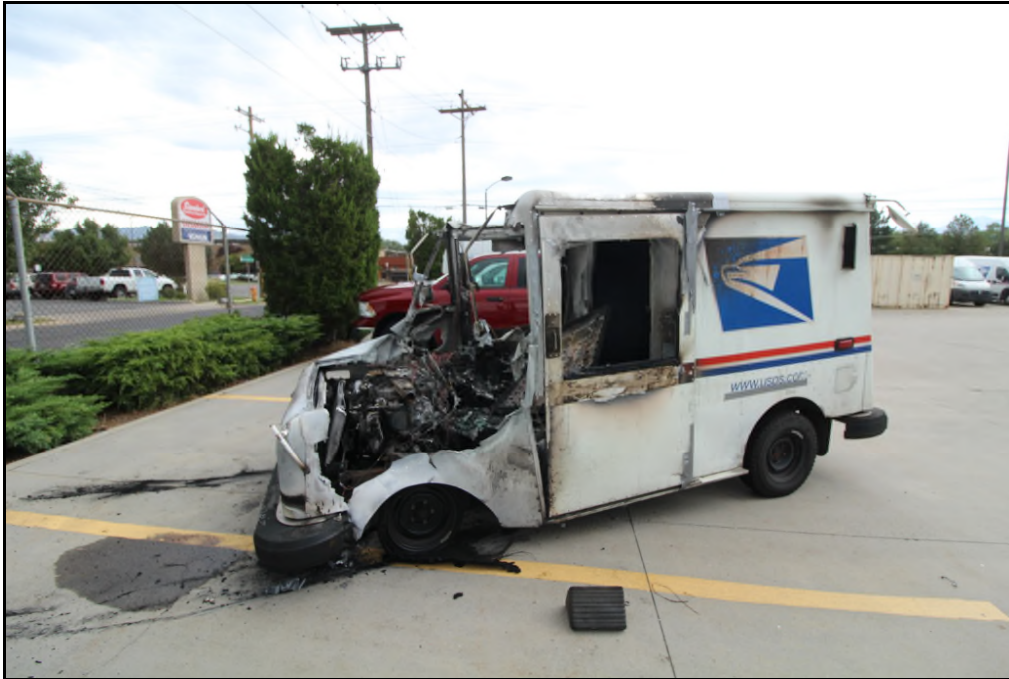
Photograph 5
Engine compartment area.

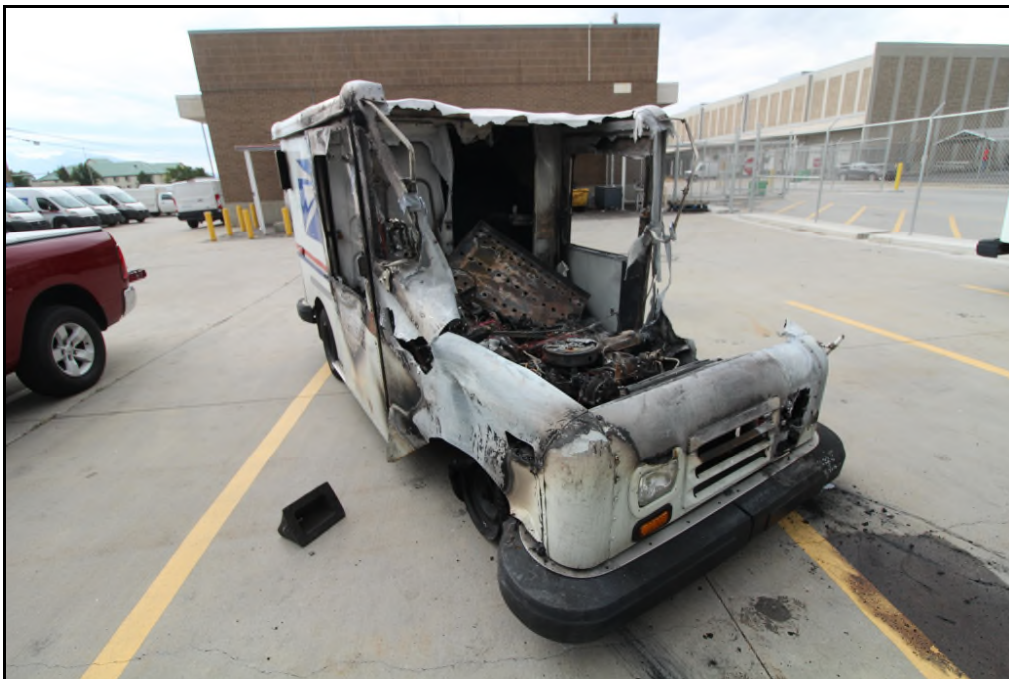
Photograph 6
Severe fire damage to the front of the vehicle and engine compartment.

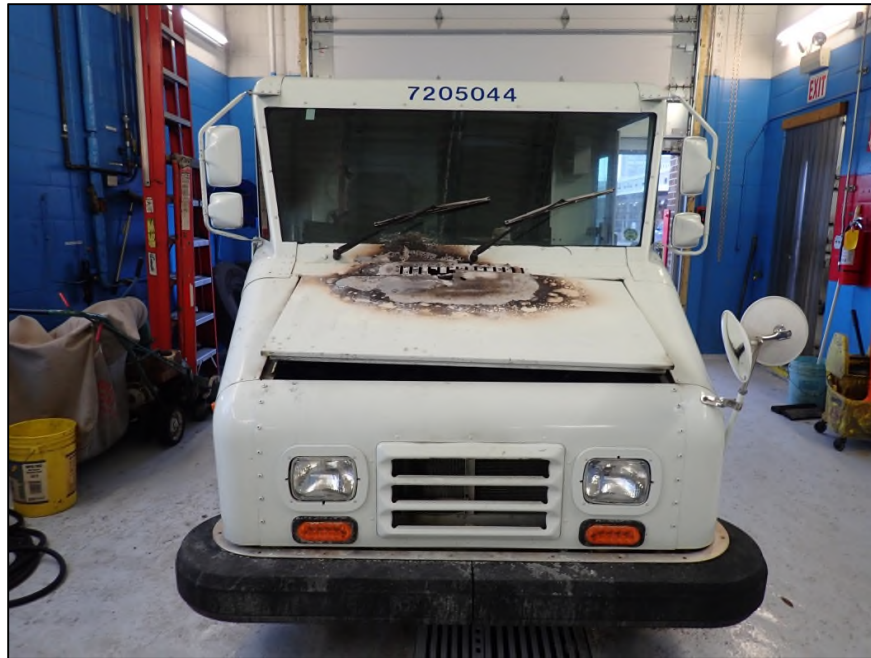
Photograph 1

View of the front of the subject LLV.

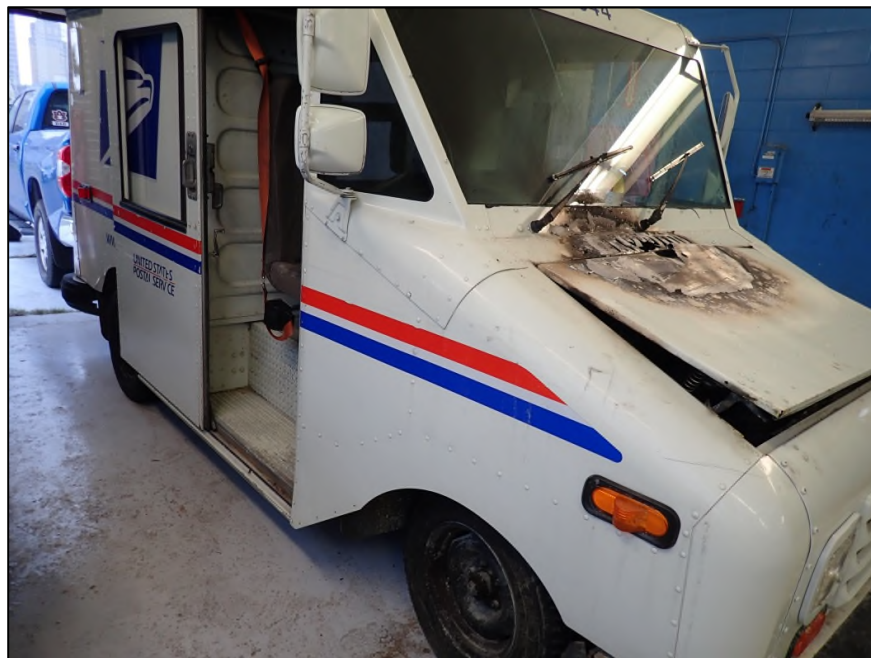
Photograph 2

View of the right side.

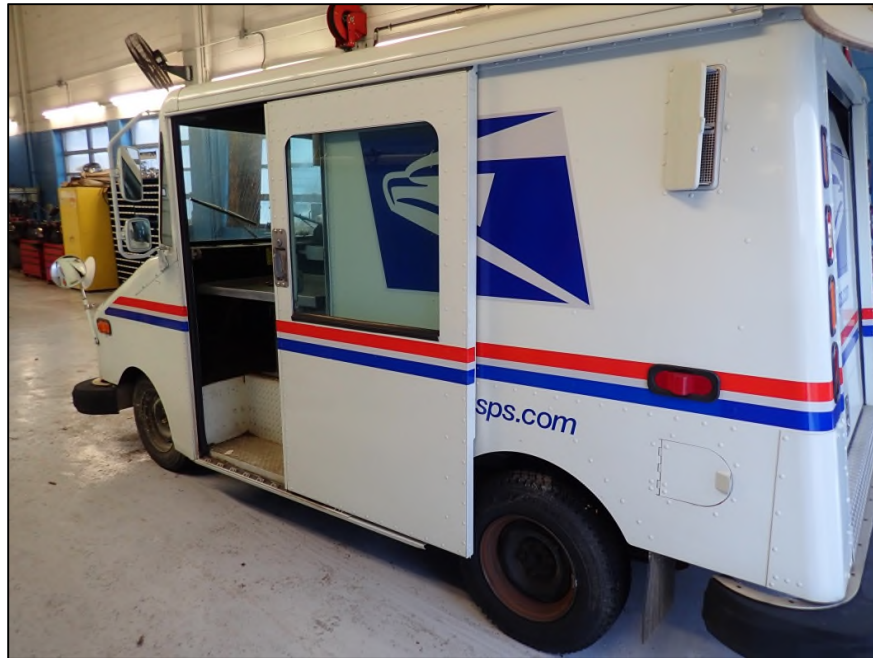
Photograph 3
View of the left side.

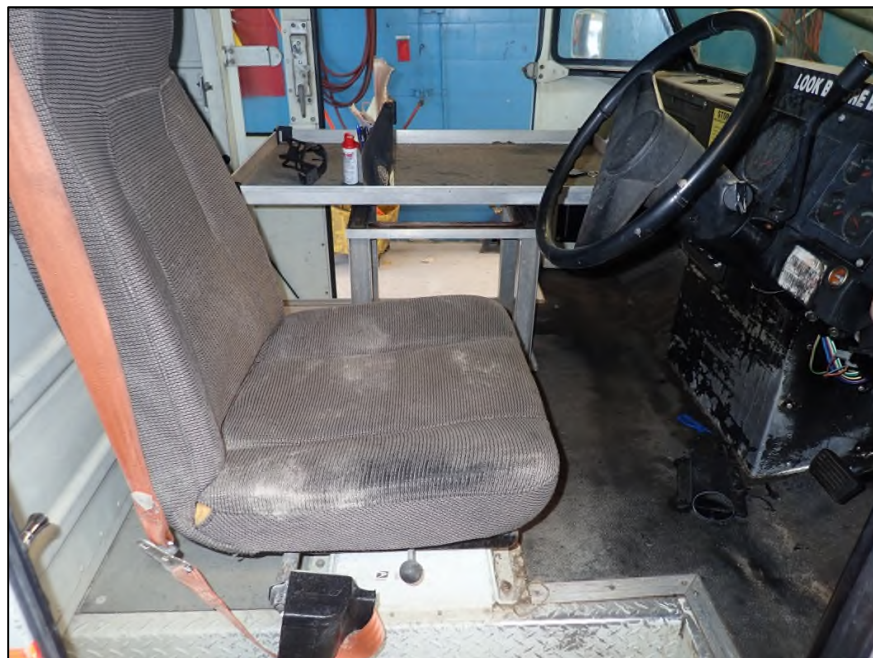
Photograph 4
View of the operator's position.

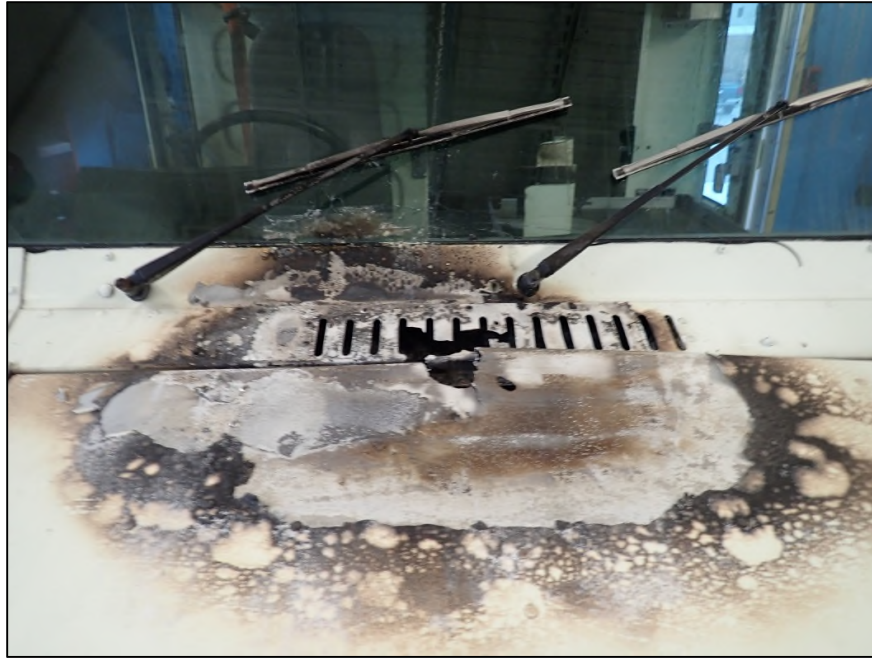
Photograph 5

View of damage to the hood.

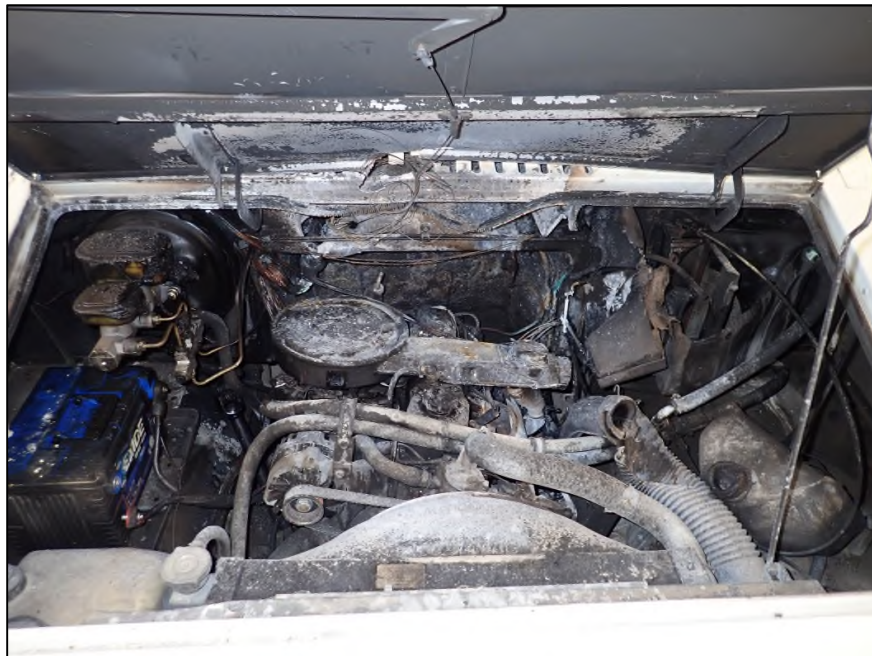
Photograph 6

View of the engine compartment.

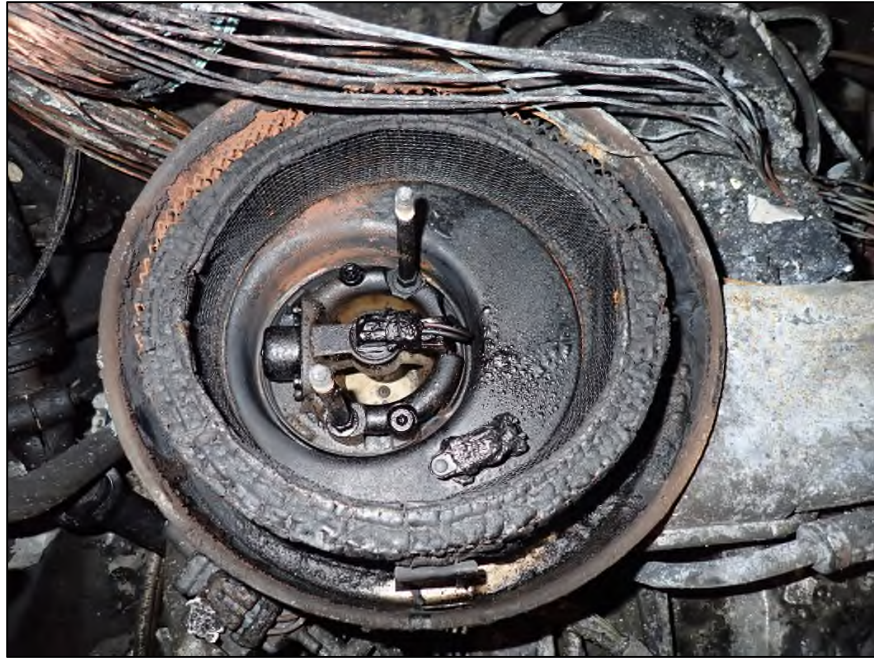
Photograph 7
View of the fuel system.

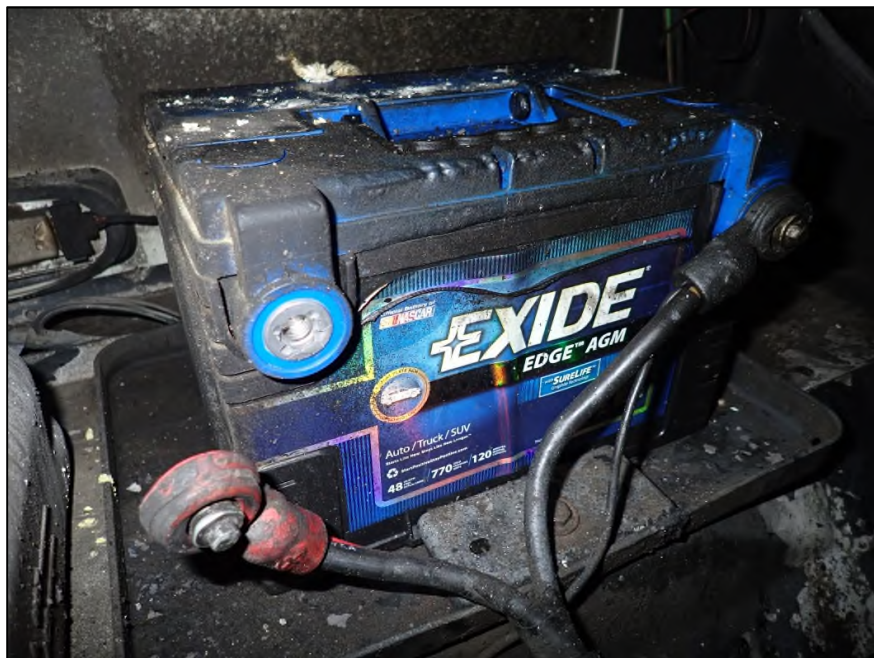
Photograph 9

View of damage typical of the wiring harnesses along the bulkhead.

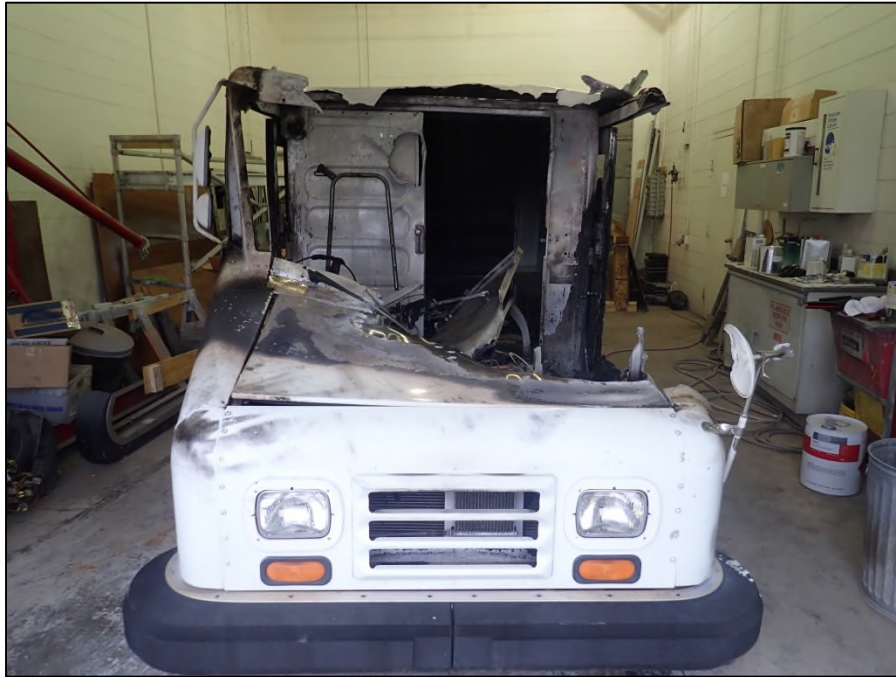
Photograph 1

Front of the vehicle, severe fire damage to the mail side of the vehicle.
